# Manhole Inspection Summary

Manhole # S02WW1009MH

Insp Date: **7/26/06 8:35 AM**

**Location** Address: **6305 Fordham Dr E**

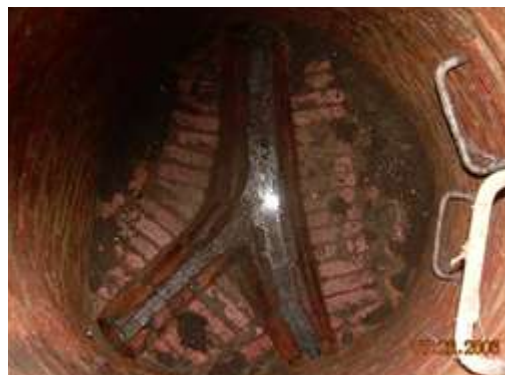
Top View

Condition: ☐ Sound ☐ Cracked ☐ Root Intrusion ☒ **Loose Brick** ☐ Deteriorated

Infiltration: ☐ None ☒ **Joint** ☐ Cracks ☐ Mortar ☐ Roots ☐ Wall

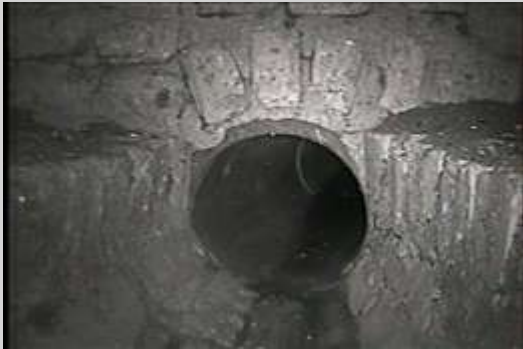
### 8 in. Circular Gravity Sewer Pipe Out @ 12 O'Clock

Pipe Material: **Clay** ☐ Pipe Lined

Invert Depth: **8.25** (ft.) Flow Characteristics: **None**

Deposits: ☒ None ☐ Mud ☐ Sludge ☐ Debris ☐ Grease

Infiltration: **None** Pipe Seal Cond: **Sound**

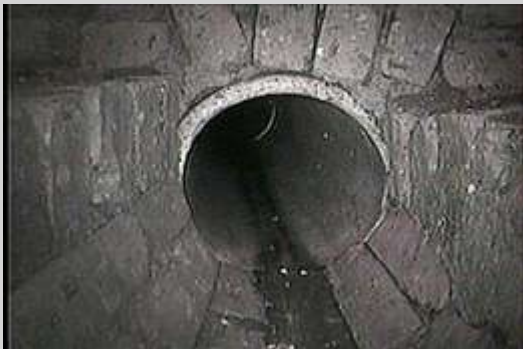
### 8 in. Circular Gravity Sewer Pipe In @ 5 O'Clock

Pipe Material: **Clay** ☐ Pipe Lined

Invert Depth: **8.16** (ft.) Flow Characteristics: **None**

Deposits: ☒ None ☐ Mud ☐ Sludge ☐ Debris ☐ Grease

Infiltration: **None** Pipe Seal Cond: **Sound**

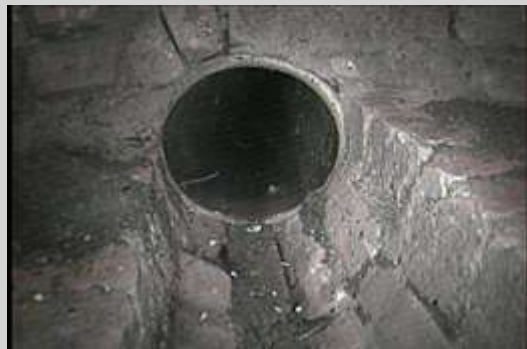
Pipe In @ 7 O'Clock

Pipe Material: **Clay**

Invert Depth: **7.70** (ft.) Flow Characteristics: **None**

Deposits: ☒ None ☐ Mud ☐ Sludge ☐ Debris ☐ Grease

Infiltration: **None**

Pipe Seal Cond: **Sound**
